**Flood Control Project Maintenance
Levee Inspections**

Maintenance Issue Types Only, Levee Inspection Report By Mile - Fall 2018

Reclamation District No. 0017 Mossdale

Waterway	Bank	Unit Miles	Inspection Start/End	Inspector
Unit No. 01 French Camp Slough	Left	1.76	09/25/2018 09/25/2018	Richard Willoughby

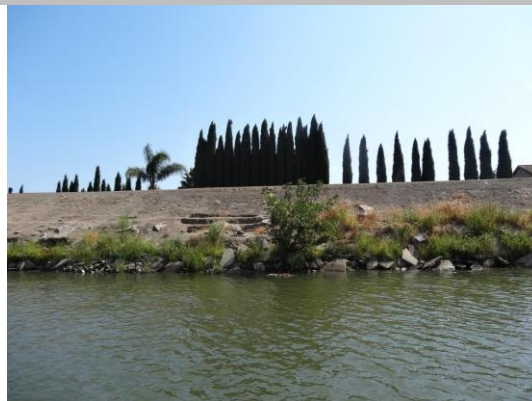
Photo 1 of 2 : FA_2018_RD0017_304_2_20180906_00003.jpg

LM Start	0.25	Rating **	M	Issue No.	2
LM End	0.26	Issue Type +	Ma	Location *	WS
Category	Supplemental		GPS Latitude/Longitude		
			Start	End	
Item	DWR Erosion Survey		37.913048 °	37.913048 °	
			-121.323561 °	-121.323561 °	
DWR ID	RD0017U02RM43.51				
Comment Code					
Inspector Comment					
09/13/2017: Erosion occurs along the levee toe. [2017 Site ID:RD0017U02RM43.51].

Front view of the erosion.

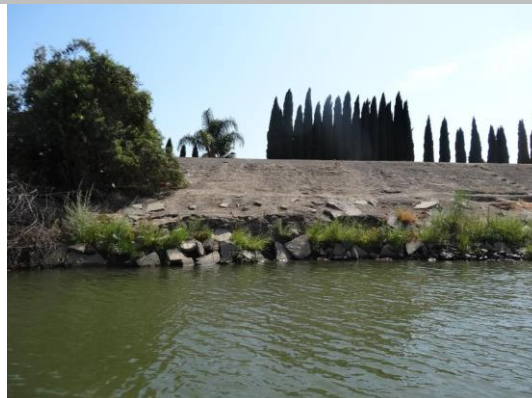
Photo 2 of 2 : FA_2018_RD0017_304_2_20180906_00006.jpg

LM Start	0.25	Rating **	M	Issue No.	2 (cont)	
LM End	0.26	Issue Type +	Ma	Location *	WS	
Category	Supplemental			GPS Latitude/Longitude		
				Start		End
Item	DWR Erosion Survey			37.913048 °	37.913048 °	
				-121.323561 °	-121.323561 °	
DWR ID	RD0017U02RM43.51					
Comment Code						
Inspector Comment						
09/13/2017: Erosion occurs along the levee toe. [2017 Site ID:RD0017U02RM43.51].

Close view of the erosion.

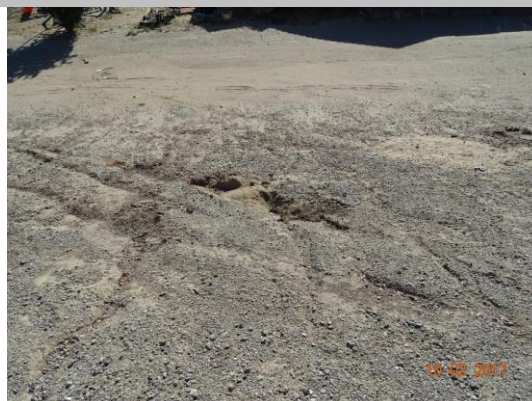
Photo 1 of 1 : FA_2018_RD0017_304_70_20180906_00011.jpg

LM Start	1.43	Rating **	M	Issue No.	70
LM End	1.43	Issue Type +	Ma	Location *	LS
Category	Earthen Levee			GPS Latitude/Longitude	
				Start	End
Item	Slope Stability			37.897508 °	37.897508 °
				-121.326671 °	-121.326671 °
DWR ID	DWR_RD0017_02_f_2017_70				
Comment Code					
S3 : Repair the levee slope damaged by vehicle traffic and prevent access where possible.					
Inspector Comment

Looking east at the landside slope.

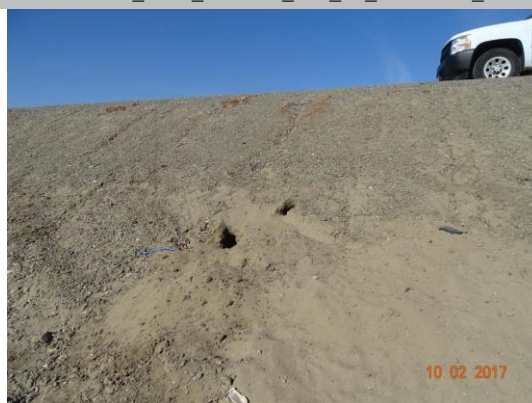
Photo 1 of 1 : FA_2018_RD0017_304_75_20180906_00013.jpg

LM Start	1.43	Rating **	M	Issue No.	75
LM End	1.43	Issue Type +	Ma	Location *	LS
Category	Earthen Levee			GPS Latitude/Longitude	
				Start	End
Item	Animal Control			37.897467 °	37.897467 °
				-121.326690 °	-121.326690 °
DWR ID	DWR_RD0017_02_f_2017_75				
Comment Code					
A3 : No rodents visible, but rodent burrows visible; need to backfill and compact or grout burrows.					
Inspector Comment

Looking west at the landside slope.

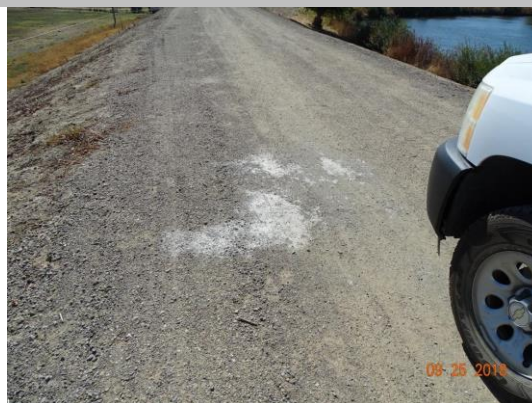
Photo 1 of 2 : FA_2018_RD0017_304_82_20180927_00201.jpg

LM Start	4.84	Rating **	A/W	Issue No.	82
LM End	4.84	Issue Type +	Ma	Location *	LS
Category	Earthen Levee			GPS Latitude/Longitude	
				Start	End
Item	Animal Control			37.856633 °	37.856633 °
				-121.319411 °	-121.319411 °
DWR ID	DWR_RD0017_02_f_2017_82				
Comment Code					
A1 : Exterminate rodents and backfill and compact or grout burrows.					
Inspector Comment					
District grouted rodent holes.

Looking south at typical view of grouted rodent holes on landward shoulder. (Fall 2018)

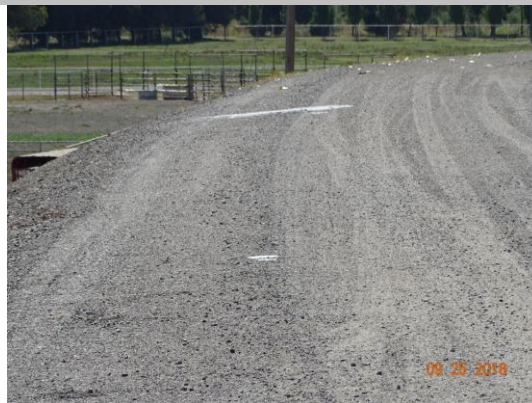
Photo 2 of 2 : FA_2018_RD0017_304_82_20180927_00202.jpg

Looking southeast at typical view of grouted rodent holes on landward shoulder and slope. (Fall 2018)

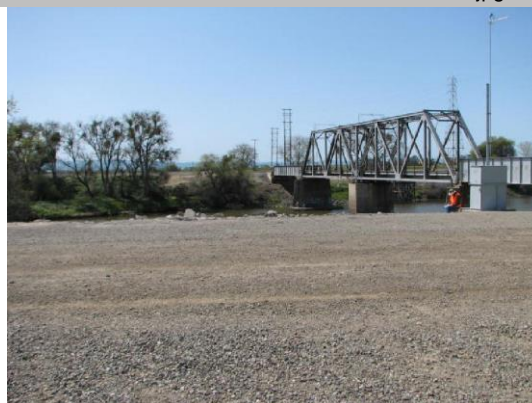
Photo 1 of 3 : UCIP_FA_2018_40715_72548.jpg

LM Start	13.28	Rating **	M	Issue No.	149	
LM End	13.28	Issue Type +	Ma	Location *		
Category	Supplemental			GPS Latitude/Longitude		
				Start	End	
Item	DWR UCIP LMA Responsibility			37.779470 °	37.779470 °	
				-121.299953 °	-121.299953 °	
DWR ID	809

Comment Code						
Inspector Comment						
FS_ID:40715						
DS_ID:809						
EP_NO: N/A						
Repair Type: Non-Urgent						
Crossing Status: Found						
UCIP Comments: No information was obtained from desk study. This crossing was found during field visit. Need to contact owner to obtain additional details about crossing (installation date and permit) and status.						
FIELD_STRUCT_DESC: *ABANDONED* [Reclamation District No. 17 Drainage Plant] 18-inch drainage pipe of unknown material through the levee, 5.8 feet below the crown. Gate valve and siphon breaker on the waterside (WS) slope. Flap gate on the WS end. One CM cutoff wall. Pump on the landside (LS). (18-inch pipe Installed by USACE in 1961 -- no permit found; existing 18-inch pipe removed under Permit No. 14450, 1988 - R. H. Brown, two 18-inch pipes installed) [Additional Reference(s): DWR Levee Logs, 1981, 2003. USACE San Joaquin O&M Manual Unit No. 2, May 1963, (HLM 13.36)]

View of levee crown at crossing.

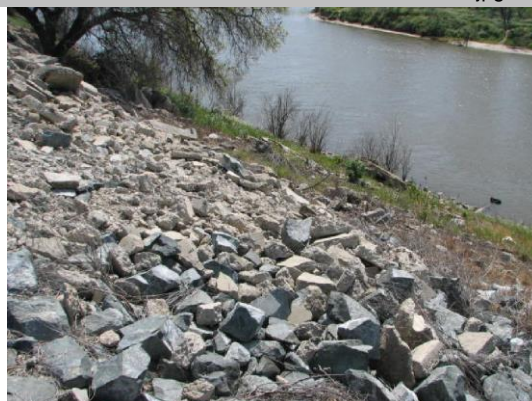
Photo 2 of 3 : UCIP_FA_2018_40715_72551.jpg

Item	DWR UCIP LMA Responsibility			37.779470 °	37.779470 °	
				-121.299953 °	-121.299953 °	
DWR ID	809					
Comment Code						
Inspector Comment						
FS_ID:40715 DS_ID:809 EP_NO: N/A Repair Type: Non-Urgent Crossing Status: Found UCIP Comments: No information was obtained from desk study. This crossing was found during field visit. Need to contact owner to obtain additional details about crossing (installation date and permit) and status. FIELD_STRUCT_DESC: *ABANDONED* [Reclamation District No. 17 Drainage Plant] 18-inch drainage pipe of unknown material through the levee, 5.8 feet below the crown. Gate valve and siphon breaker on the waterside (WS) slope. Flap gate on the WS end. One CM cutoff wall. Pump on the landside (LS). (18-inch pipe Installed by USACE in 1961 -- no permit found; existing 18-inch pipe removed under Permit No. 14450, 1988 - R. H. Brown, two 18-inch pipes installed) [Additional Reference(s): DWR Levee Logs, 1981, 2003. USACE San Joaquin O&M Manual Unit No. 2, May 1963, (HLM 13.36)] FS Date: 2/4/2010

View of waterward side, photo 1 of 2.
